United States Environmental Protection Agency  
Region 7  
Enforcement and Compliance Assurance Division

**Air Branch Inspection Report  
Announced Full Compliance Evaluation  
Butler County Sanitary Landfill**  
6038 Highway T  
Poplar Bluff, MO 63901  
FRS# 110010427564

**Inspection Date(s):**  
June 22, 2022

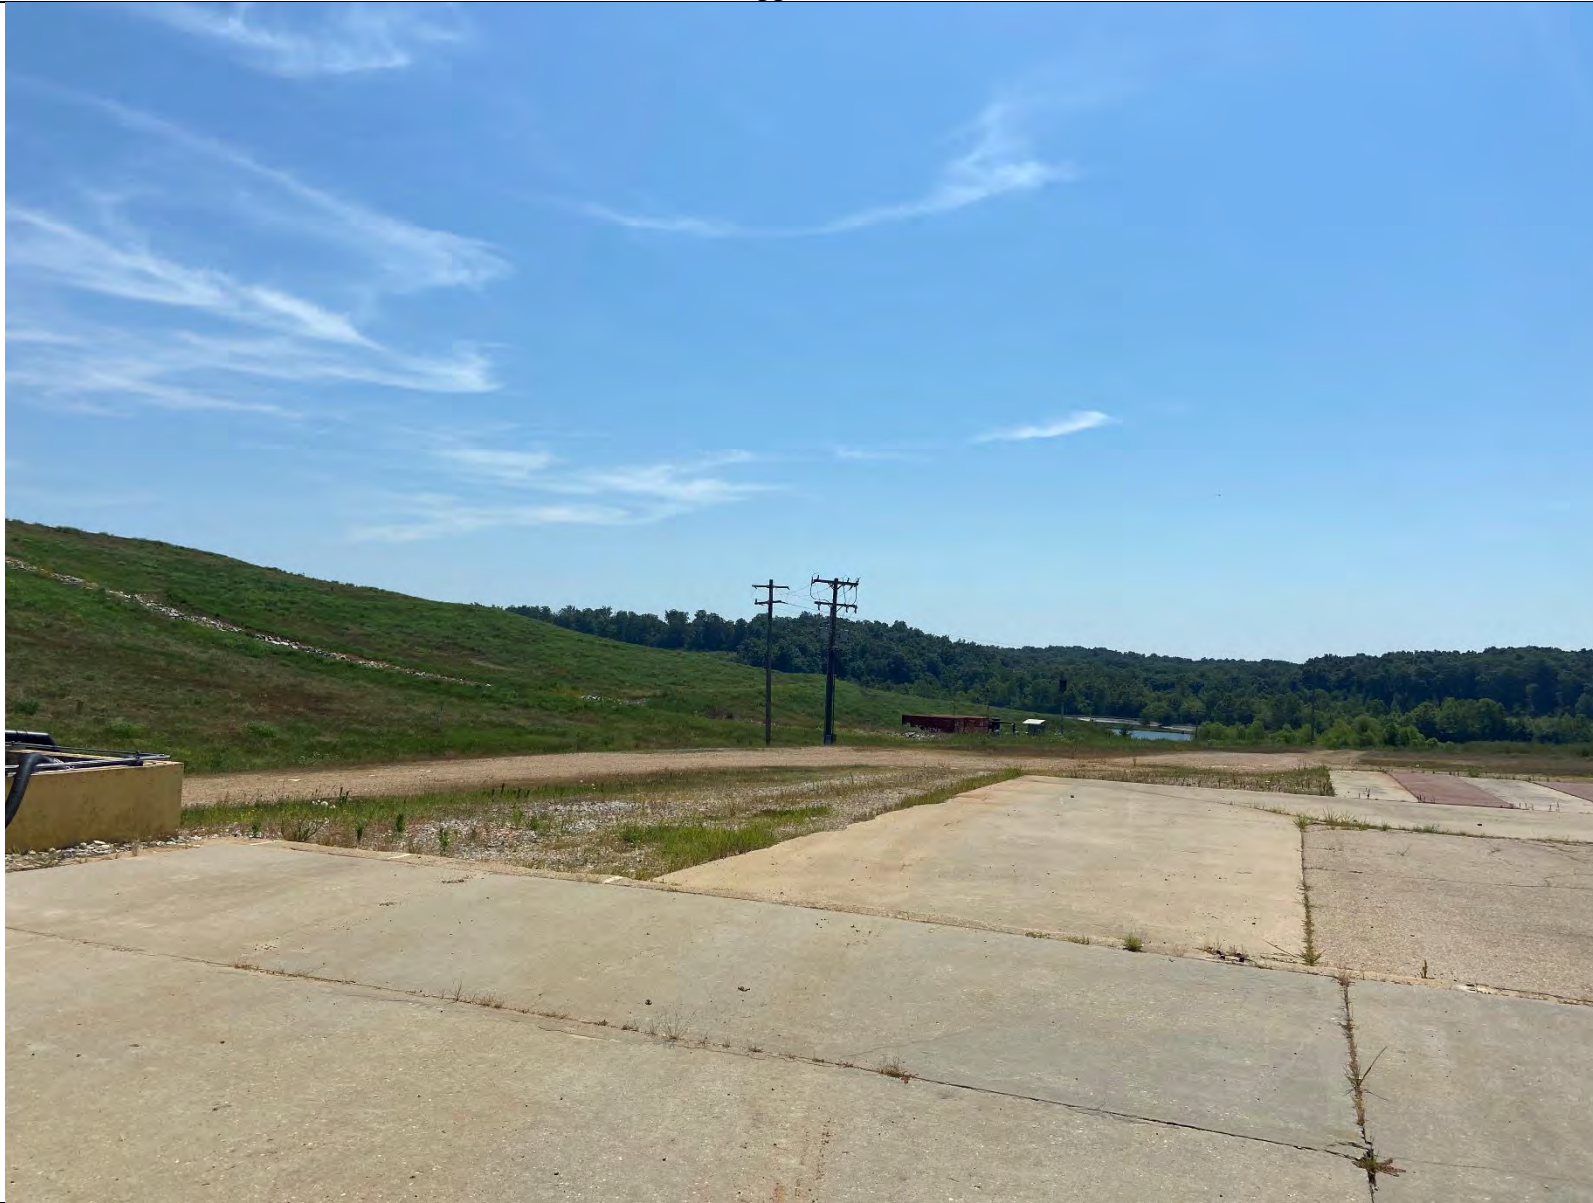
Digital Image Number	File Name	Description of Digital Image	Date/Time Digital Image Taken
1	IMG_5840	Southwest slope of the landfill (facing northeast)	6/22/22 11:02 AM
2	IMG_5841	South slope of the landfill and surrounding area with stormwater retention pond in the back (facing east)	11:02 AM
3	IMG_5843	South slope of the landfill (facing north)	11:10 AM
4	IMG_5844	Flare that is no longer in use (facing northeast)	11:10 AM
5	IMG_5845	Vegetation opposite of the landfill (facing south)	11:10 AM
6	IMG_5846	Storm water retention pond (facing southeast)	11:10 AM
7	IMG_5847	Scada telemetry weather monitor	11:12 AM
8	IMG_5848	SLIGO instruments to monitor the flare and leachate system	11:12 AM
9	IMG_5849	South slope of landfill (facing north)	11:16 AM
10	IMG_5850	South slope of the landfill (facing northwest)	11:16 AM
11	IMG_5851	Southeast slope of landfill (facing northeast)	11:16 AM
12	IMG_5852	Close-up of storm water retention ponds (facing southeast)	11:20 AM

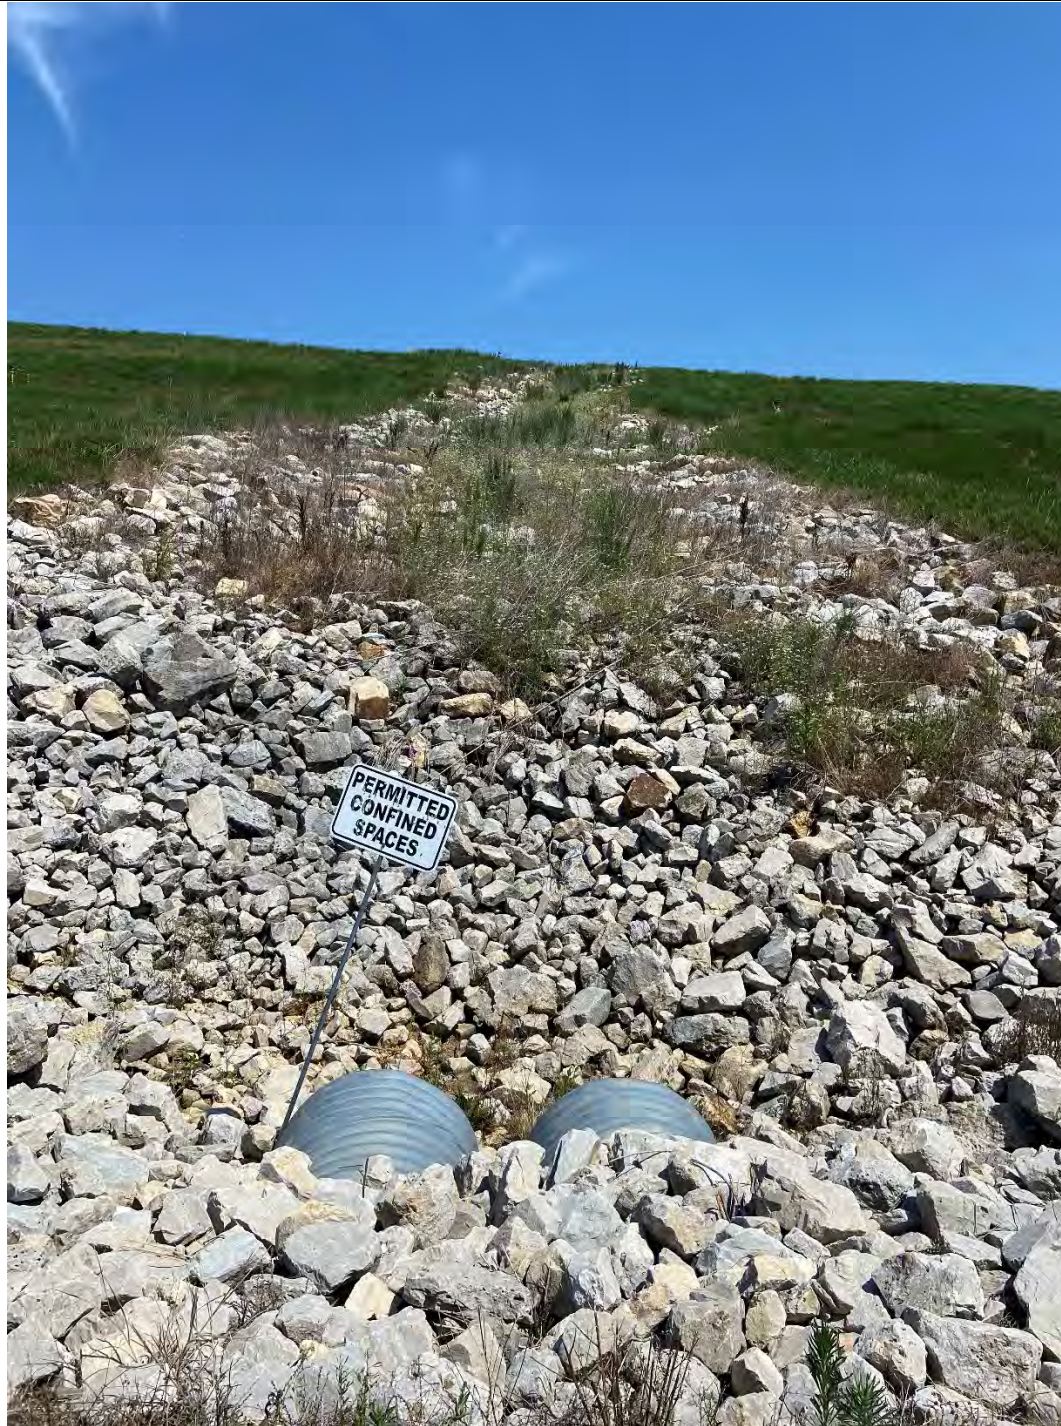
13	IMG_5853	Storm water let down area (facing north)	11:23 AM
14	IMG_5854	Southwest slope of the landfill (facing northeast)	11:26 AM
15	IMG_5855	West slope of the landfill (facing east)	11:26 AM
16	IMG_5856	West slope of landfill (facing southeast)	11:26 AM
17	IMG_5857	West slope of landfill (facing south)	11:27 AM

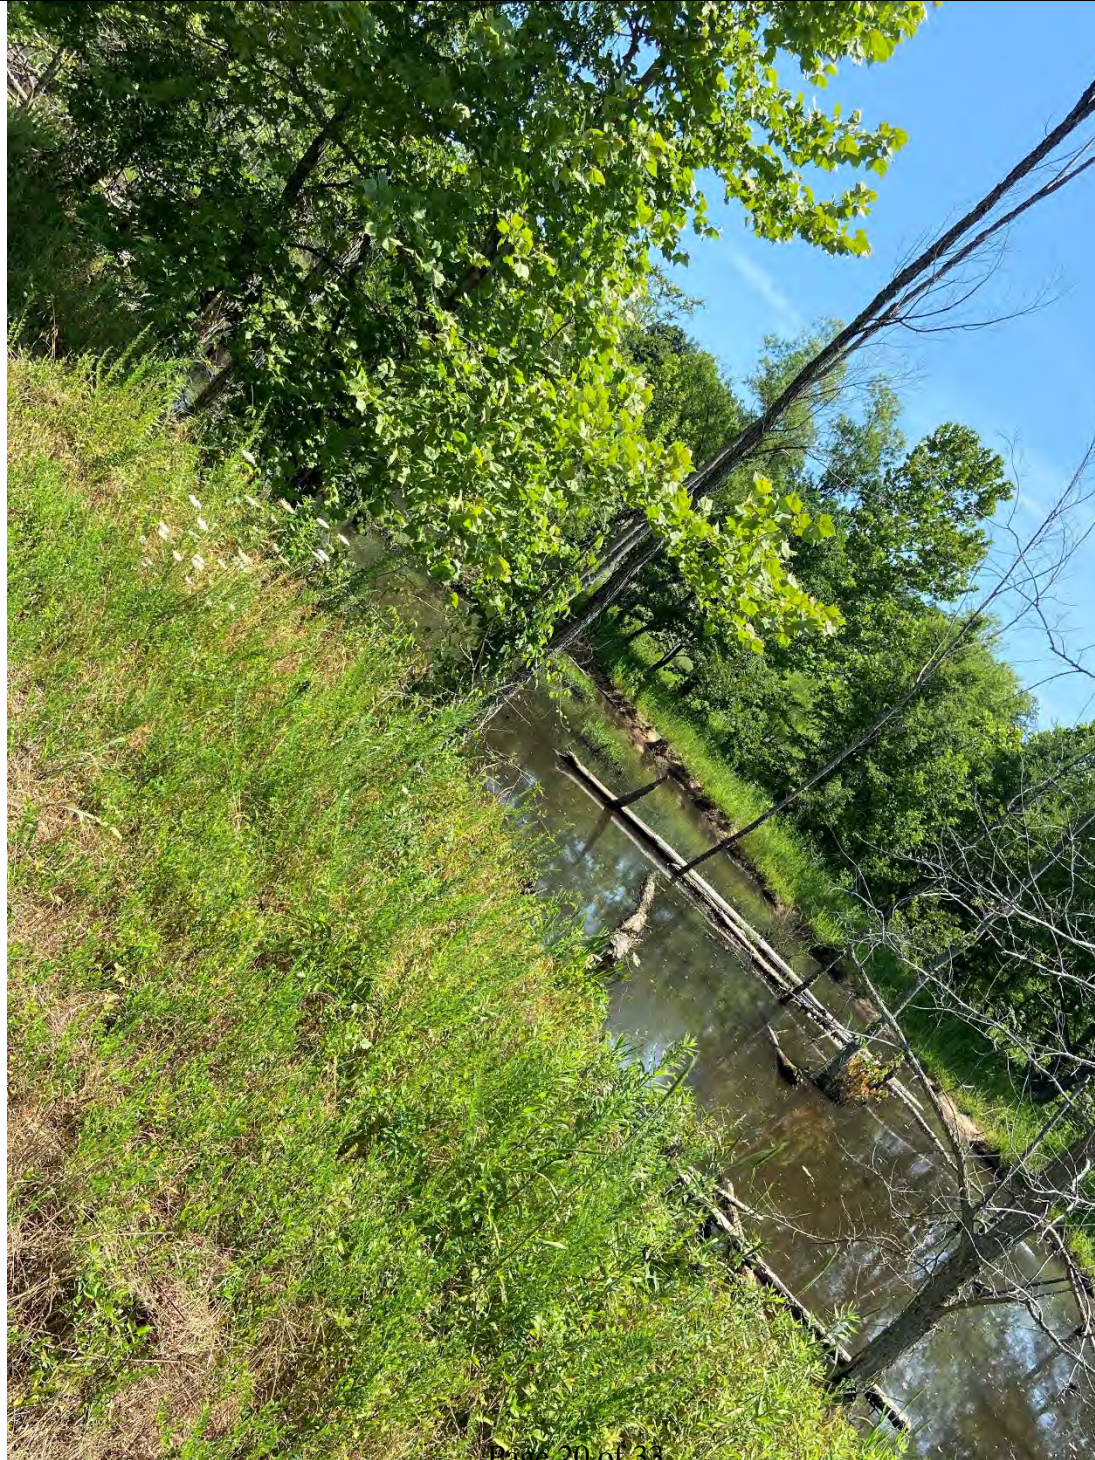
18	IMG_5858	River beside the landfill (facing northeast)	11:27 AM
19	IMG_5859	Damn in the river (facing east)	11:32 AM
20	IMG_5860	Close-up of a capped gas well (facing north)	11:35 AM
21	IMG_5861	Surrounding environment of the landfill (facing northwest)	11:35 AM
22	IMG_5862	Surrounding environment of the landfill (facing north)	11:35 AM
23	IMG_5863	Unidentifiable item in the surrounding environment of the landfill (facing north)	11:36 AM
24	IMG_5864	North slope of the landfill (facing south)	11:36 AM
25	IMG_5865	North slope of the landfill (facing southeast)	11:38 AM
26	IMG_5866	Close-up of a capped well on the north slope (facing south)	11:38 AM
27	IMG_5867	Close-up of a capped well on the north slope (facing southeast)	11:38 AM
28	IMG_5868	North slope of landfill (facing south)	11:38 AM
29	IMG_5869	Other capped well in the surrounding environment of landfill (facing north)	11:39 AM
30	IMG_5870	Surrounding environment of the landfill (facing west)	11:39 AM

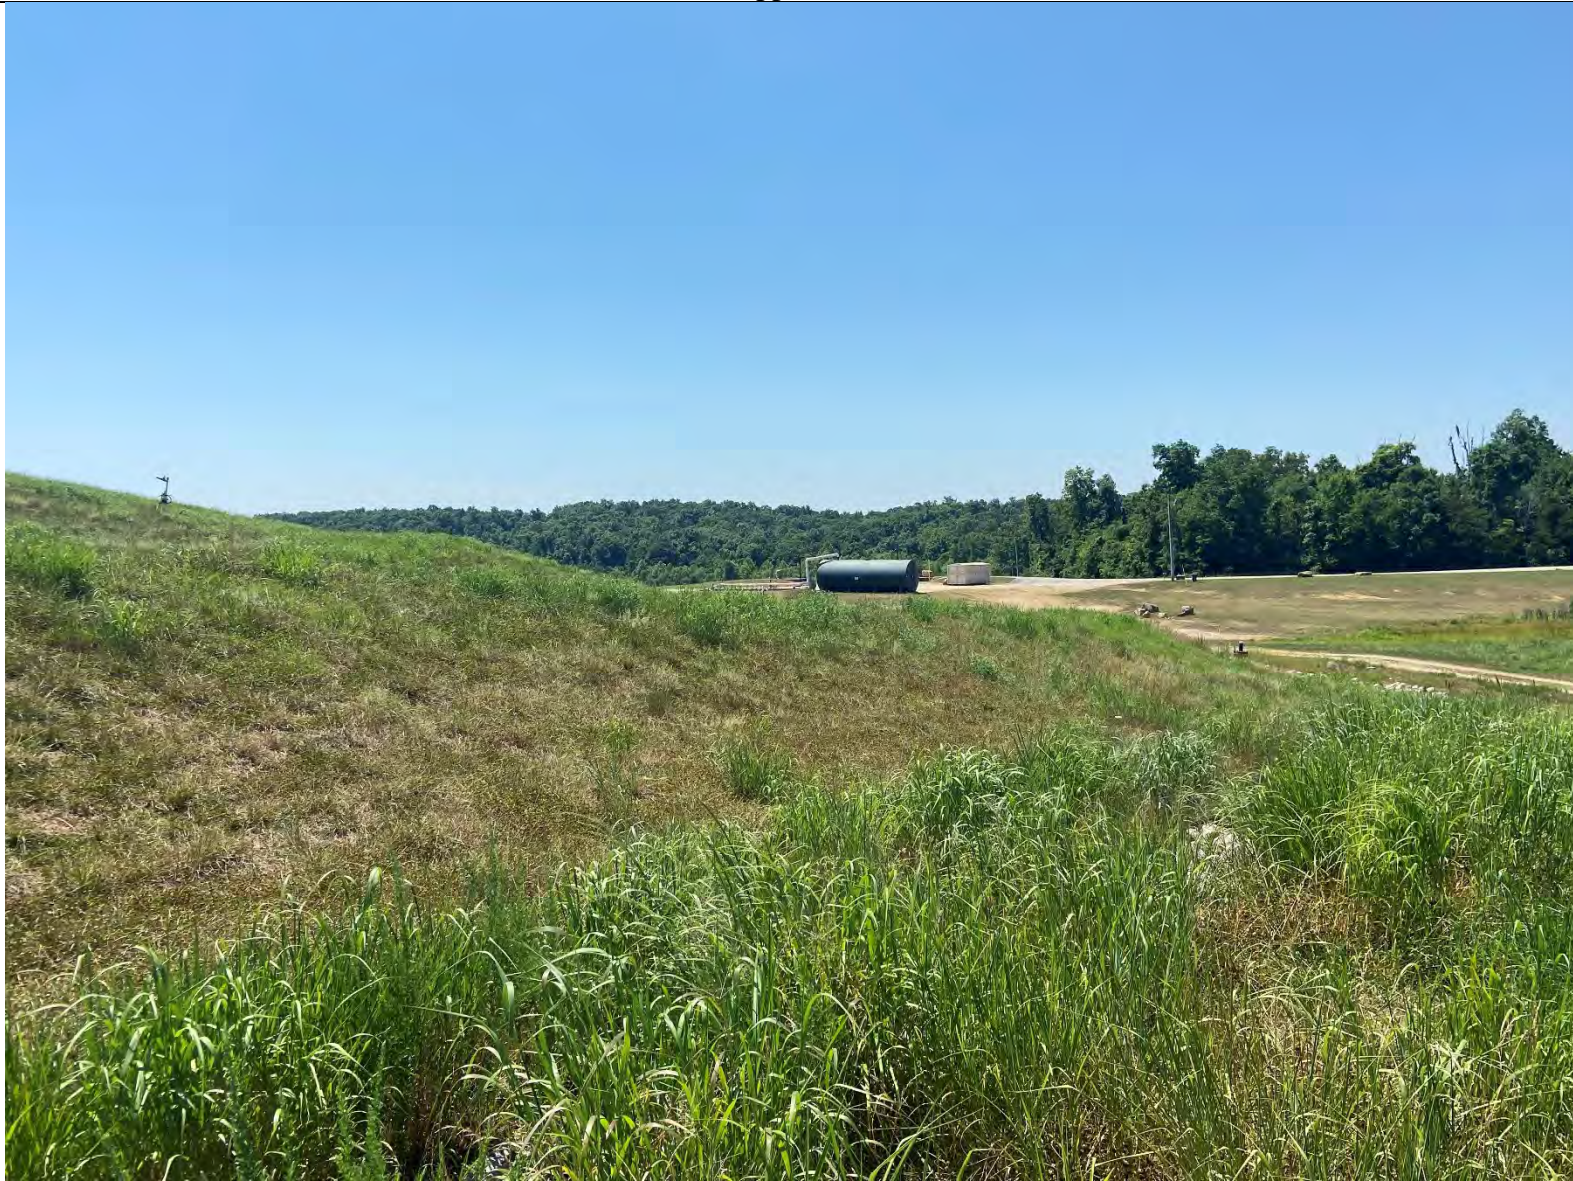
31	IMG_5871	Northeast slope of the landfill (facing south)
